## HANGAR FLOOR SETTLEMENTS AT THULE AIR BASE, GREENLAND

TECHNICAL REPORT NO. AFWL-TR-69-122

March 1970

AIR FORCE WEAPONS LABORATORY  
Air Force Systems Command  
Kirtland Air Force Base  
New Mexico

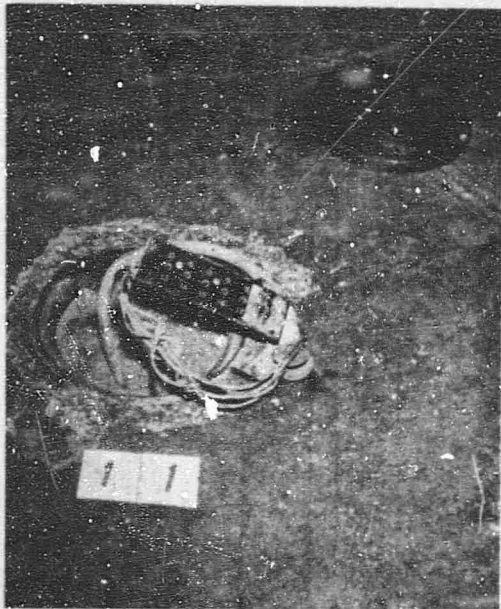
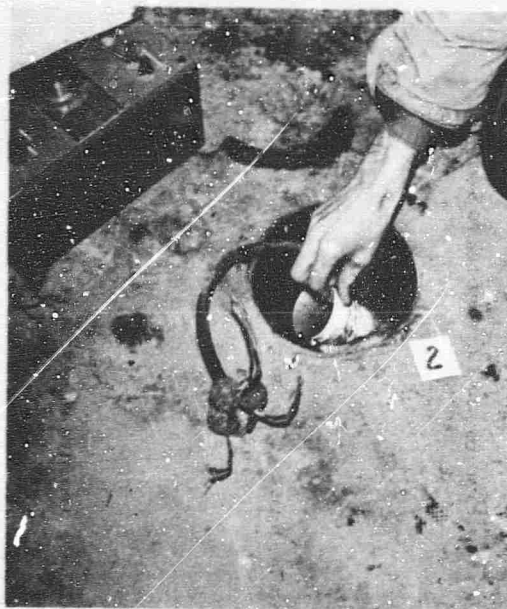
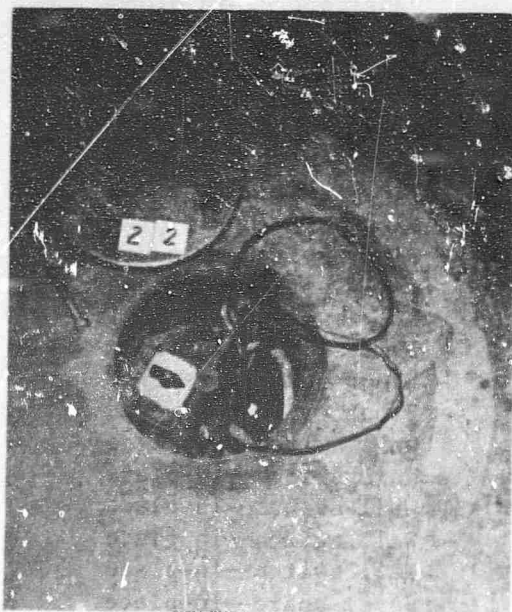
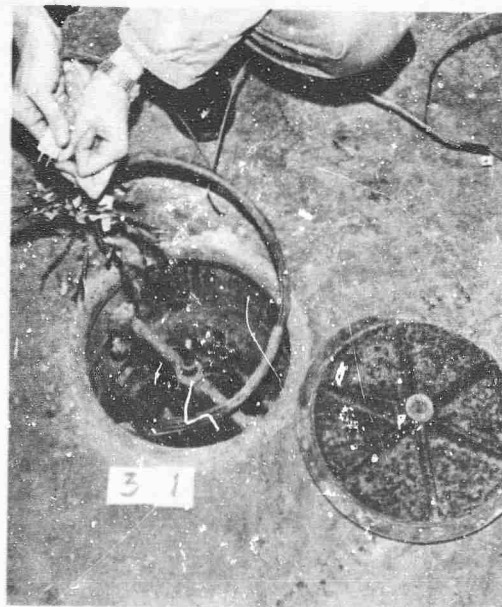
Figure 4. Present Condition of Typical Thermocouple Assemblies

When possible, switches and panel boards were cleaned and reconnected. Several damaged panel boards and corroded switches were removed. Continuity was established both before and after disconnecting each wire and tags were installed. The present condition of all assemblies is listed in table I. Photographs of typical switch and panel board assemblies are shown in figure 4.

Where switches and panel boards have been removed, measurements must now be taken by holding the bare wires against the copper-constantan plug of the jumper cable. This scheme is slow and tedious and it is suggested that replacement switches and panel boards be secured for these assemblies. Since most panel boards in hangars 1 through 9 are badly corroded, it is suggested that they be replaced under Phase II of this study if pursued.

All thermocouples were read with a Leeds and Northrup No. 8686 precision potentiometer. An ice bath reference junction was used. Although several switches and panel boards were damaged, the sensors themselves were in excellent condition. All 100 thermocouples in hangars 1 through 9 were operable and of the 428 sensors in hangar 10, only five could not be used. Overall, more than 99 percent of the sensors were functioning, though many were over 15 years old. Even those located directly below the 2.2-foot deep settlement depression in hangar 10 were functioning.

- a. Although installed temperature sensors are in excellent condition, several new panel boards and switches are needed.
- b. The internally-compensated precision potentiometer in use by the Civil Engineering Division is not an adequate readout device for measuring subsurface temperatures using the installed instrumentation.

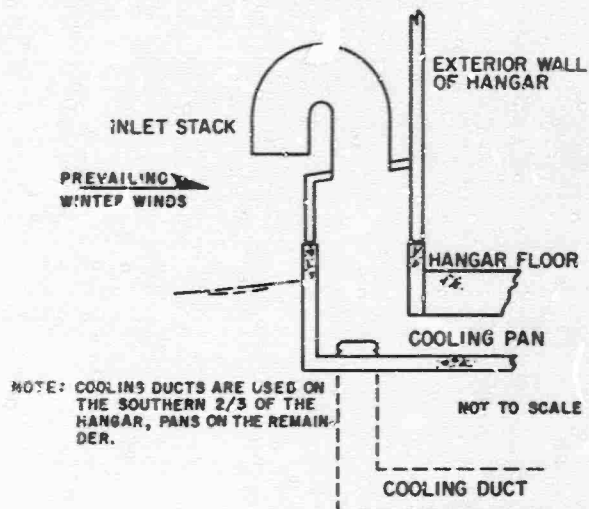
Figure 5. Inlet End of Soil-Cooling System, Hangar 3

Only the upwind end of the soil cooling system in hangar 3 could be examined. The downwind ventilation structure is between inner and outer building walls and personnel access is not possible. The upwind stacks and manifold are completely outside the hangar wall. Entrance is facilitated by doors at the north and south ends of the upwind manifold. Cooling ducts were installed about 5 feet below the southern two-thirds of the hangar floor, but pans directly below the concrete floor slab are used to cool the northerly third. All pans were clear under the hangar as far as one could see with a flashlight (about 50 feet). Air velocities in the pans were 1 to 2 mph. Although the latter could result from blockages near the downwind end, it was felt that, in part, these low velocities were caused by the shape of the inlet stacks. As shown in figure 5 the stacks do not open into the wind but are, in effect, upsidedown chimneys that tend to draw air out of, rather than force air into the upwind manifold. Suction on the downwind end of the building probably offsets the upwind chimney effect producing a net downwind flow through the ducts.

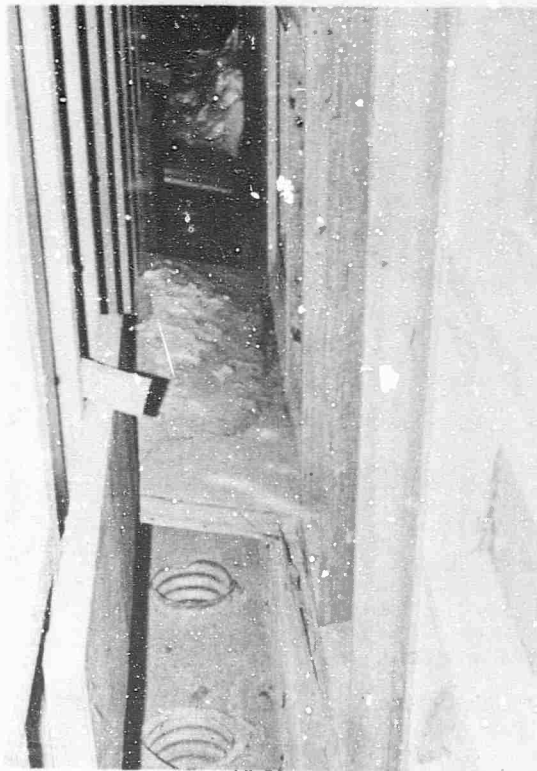
Figure 6. Exhaust Structure Showing False Floor, Hangar 4

through the ducts (figure 6). In hangar 4 all of these doors were open. The fixed portion of the false floor was covered with up to 6 inches of snow.

Further inspection revealed that horizontal timbers high in the exhaust structure were also covered with snow. From these observations it was concluded that air is both exiting and entering the vents high on the wall. Air warmed by passing through the soil-cooling ducts rises in the exhaust stack and exits through the vents while cold outside air and snow enters. A possible flow pattern is shown in figure 7.

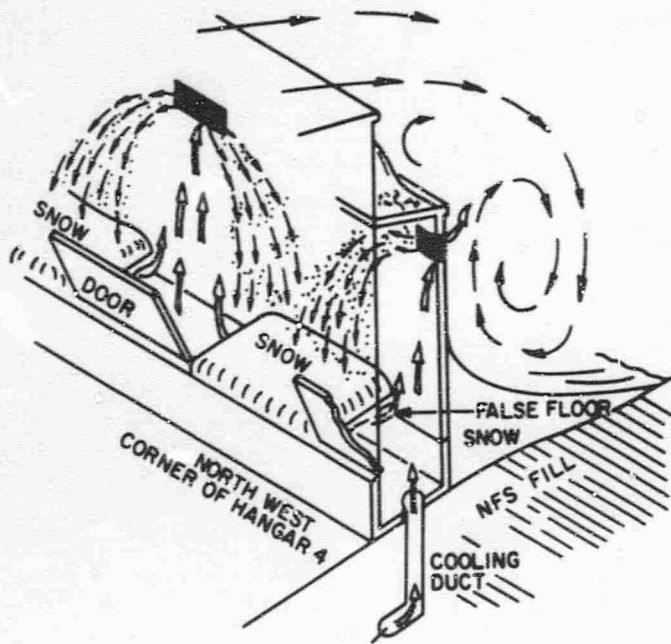
Figure 7. Two-Directional Flow in the Exhaust Structure, Hangar 4

It is evident that little chimney effect is being derived at the downwind end of hangar 4.

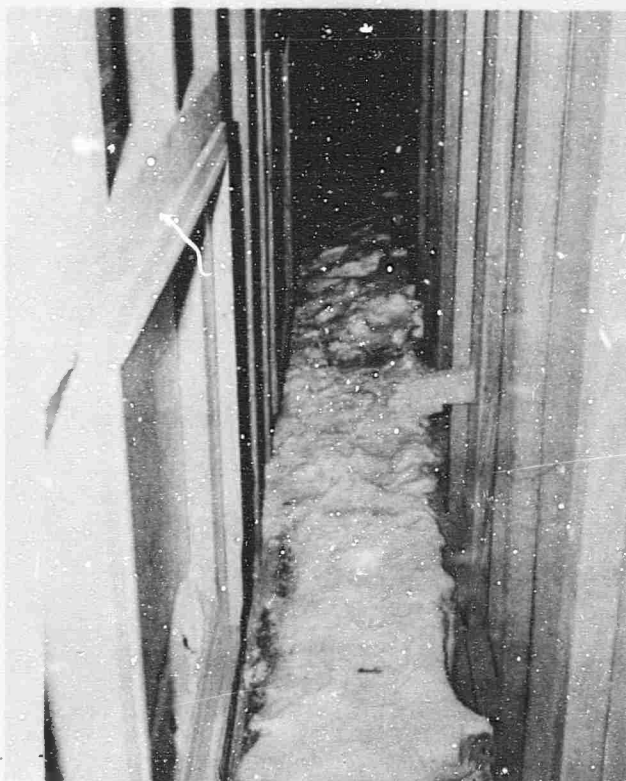
Figure 3. Snow Covering Closed Doors of False Floor in Exhaust Structure, Hangar 5

No snow was present in the upwind end of the hangar 5 soil-cooling system. Air velocity in the duct risers was measured at about 4 mph downward. Only 7 seven of the 11 doors in the false floor at the downwind end of the hangar were open. A 2- to 4-inch blanket of snow covered the fixed portion of the false floor and the four closed doors as shown in figure 8. The snow indicates that air both exits and enters the hangar 5 exhaust chamber as was described for hangar 4. Less snow was present in the downwind end of hangar 5 and duct velocities (4 to 40 1/2 mph) were higher than in hangar 4. This indicates that the soil-cooling system in hangar 5 draws air somewhat more effectively than the hangar 4 system.

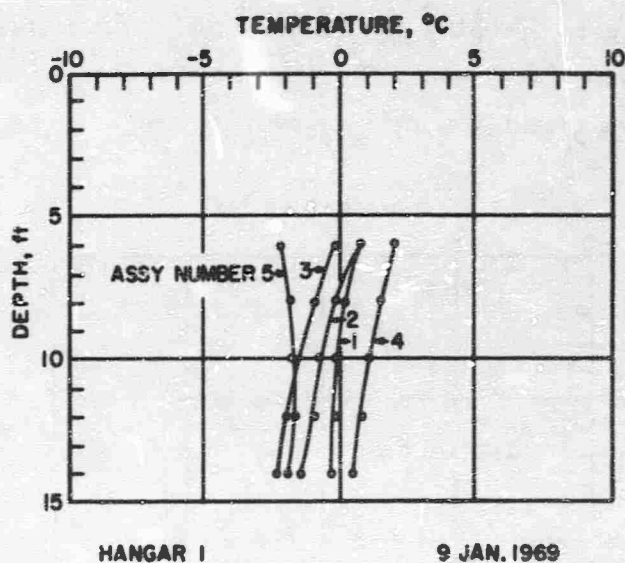
Figure 10. Measured Temperature Profiles, Hangar 1

Temperature profiles as measured on 9 January for the five thermocouple assemblies in hangar 1 are shown in figure 10. They indicate that the 0°C (32°F) isotherm has penetrated to a depth exceeding 14 feet below the area of maximum floor settlement as shown in figure 11. It appears that localized deep thaw penetration has caused the settlement. The information in table II suggests that several feet of native soil have been thawed. It is important to note that the maximum depth of thaw closely coincides with the location of the well from which ground water has been pumped from under the hangar.

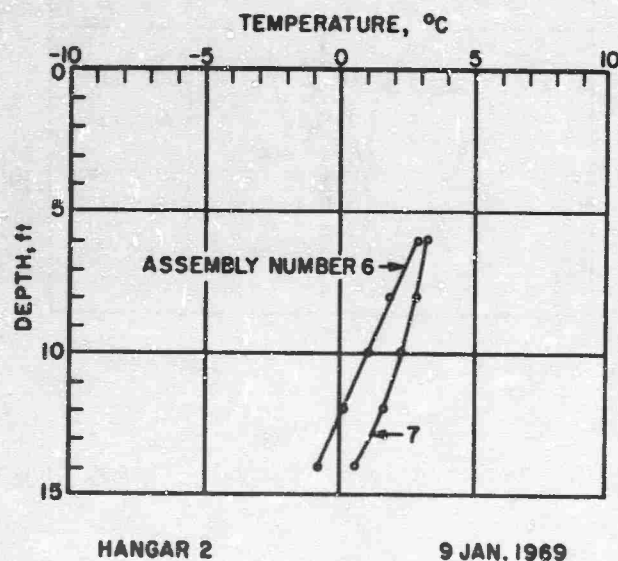
Figure 12. Measured Temperature Profiles, Hangar 2

The two thermocouple assemblies in hangar 2 indicate that on 9 January along the north-south centerline at distances of 18 and 45 feet from the south well, the depth of thaw was about twice that observed at similar positions in hangar 1 (figure 12). Hangar 2 has suffered severe floor settlement and the increased depth of thaw there is further evidence that the distress is the result of thawing frost-susceptible native soil. The 3-1/2-foot deep depression in hangar 2 is not centered in the western half of the hangar but is more nearly on the centerline. This is strong evidence that pumping has been a major cause of localized thaw deepening since pumping in that hangar has been conducted from both the northwest water well and one located near the center of the hangar. Ground water pumping from under other hangars has been accomplished from the northwest water well and the center of the settlement depression for these hangars has consistently formed below that area.

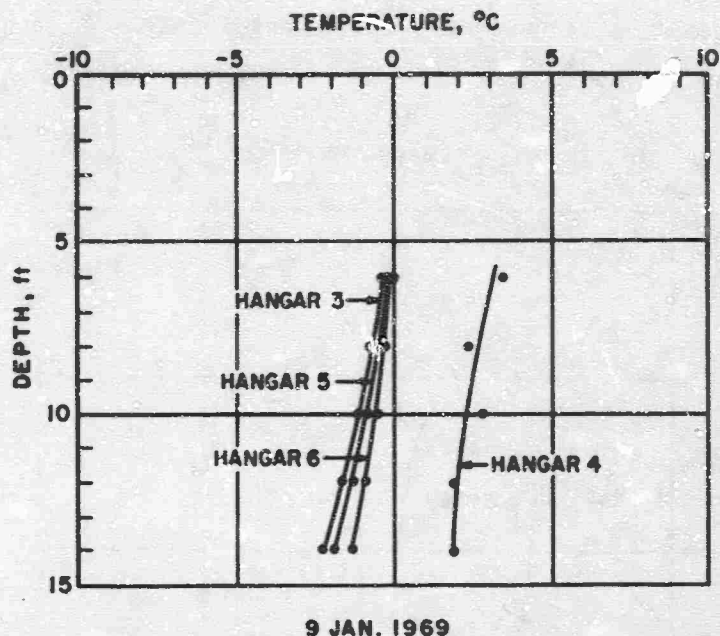
Figure 13. Measured Temperature Profiles, Hangars 3, 4, 5, and 6

The single thermocouple assembly (No. 7A) in hangar 3 indicates that thaw has penetrated to a depth of about 5-1/2 feet (figure 13).

The absence of a significant below-freezing temperature at the top thermocouple indicates that the cooling ducts are not having a very pronounced effect in that area (this point will be expanded upon when discussing the performance of hangars 7 through 10). The shallow depth of thaw is attributed to adequate operation of the soil-cooling system and edge cooling due to the relatively narrow width of this hangar. Since the downwind end of the soil-cooling ducts are the least effective because of progressive warming of the cooling air as it

passes along the duct, it is felt that the depth of thaw penetration is even less than 5-1/2 feet toward the upwind (east) end of the hangar.

The 9 January thermocouple readings in hangar 4 indicate a depth of thaw near the downwind (west) end in excess of 15 feet (figure 13). Very warm temperatures were measured and downward extrapolation of the temperature profile would indicate an exceedingly deep thaw. It is believed that the subsurface flow channel under hangar 4, detected in 1958 and described previously, still exists and is responsible for this localized deep thaw. Differential floor settlement near the doors and in the western third of the hangar was evident in 1958 (Ref. 4).

The thermocouple assembly in hangar 5 and the one in hangar 6 indicate below-freezing temperatures (figure 13). As suggested for hangar 3, the absence of significantly colder temperatures at a depth of 6 feet indicates that the soil-cooling ducts are not, at this time, freezing back the soil below. To evaluate the overall performance of the soil-cooling system in these hangars, subsurface temperatures throughout the following season would be necessary. The proximity of the hangar 6 temperature profile to the 0°C (32°F) line at a depth of 14 feet (figure 13) indicates that of the two hangars, thawing is likely to be deeper under hangar 6 during the next thawing season.

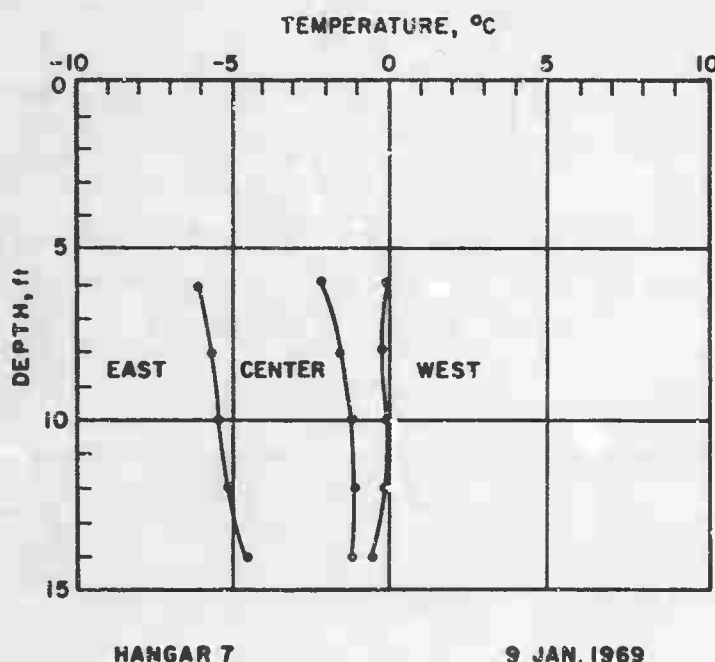
Figure 14. Measured Temperature Profiles, Hangar 7

The three temperature profiles for hangar 7 are shown in figure 14. On the upwind (east) end of the hangar, the cooling effect of the ducts is quite evident. Near the center of the hangar it is somewhat less and on the downwind end very little cooling is evident. Temperatures at the downwind end are dangerously close to thawing throughout the depth of instrumentation.

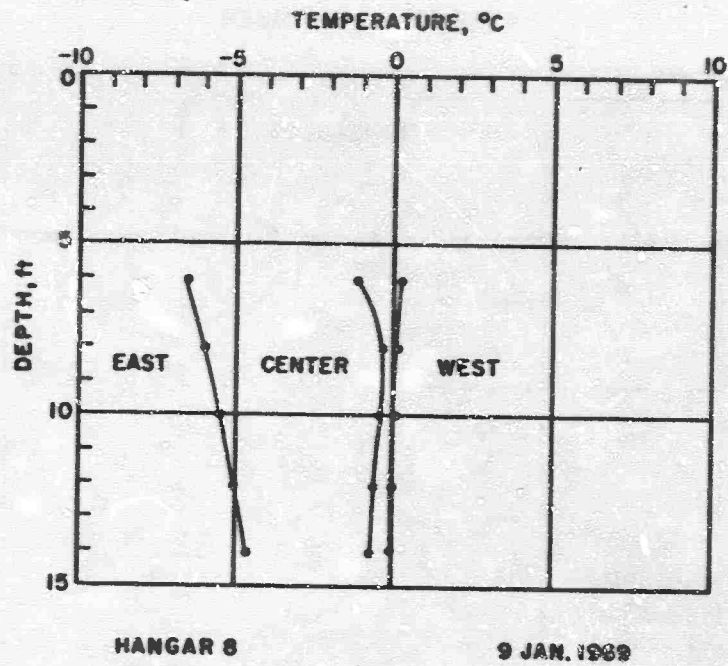
Figure 15. Measured Temperature Profiles, Hangar 8

The temperature profiles for hangar 8 (figure 15) show a similar decrease in soil cooling, progressing from east to west in the hangar. Near the west end the soil is isothermal at the freezing point and thaw probably exceeds a depth of 14 feet.

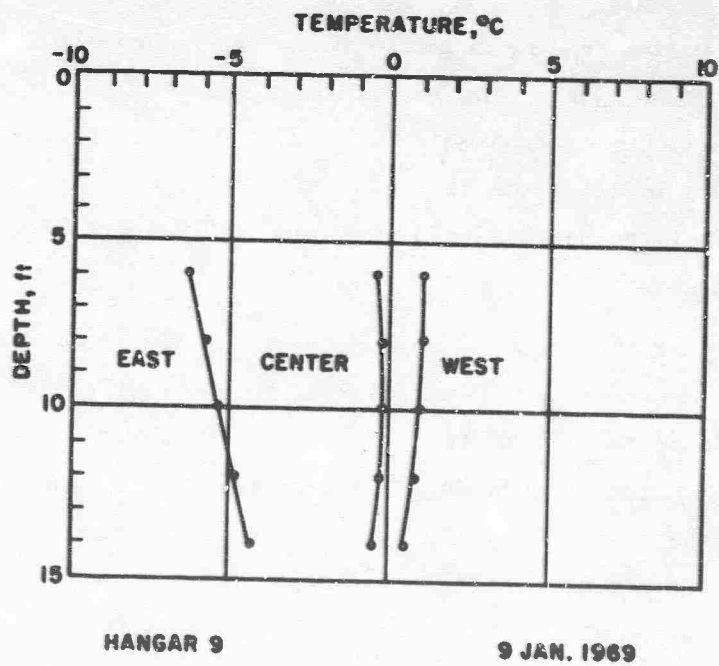
Figure 16. Measured Temperature Profiles, Hangar 9

The condition is even more severe for hangar 9 where above-freezing temperatures are evident throughout the instrumented depth on the western end of the hangar (figure 16). This is probably because of partial blockage of the downwind end of nine ducts in this area.

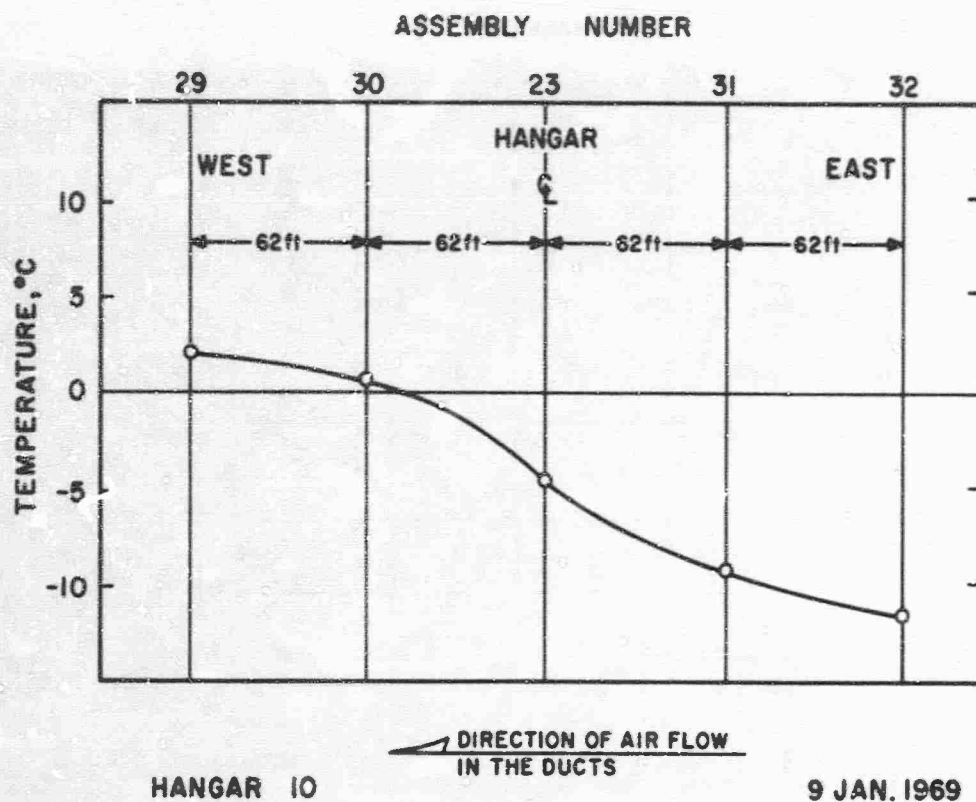
Figure 17. Measured Duct Temperatures along the East-West Line of Instrumentation, Hangar 10

A decreasing effectiveness of the downwind end of the soil-cooling ducts is also evident in hangar 10 (figure 17). Air was flowing through the instrumented duct when the measurements in figure 17 were obtained. Thaw has progressed to

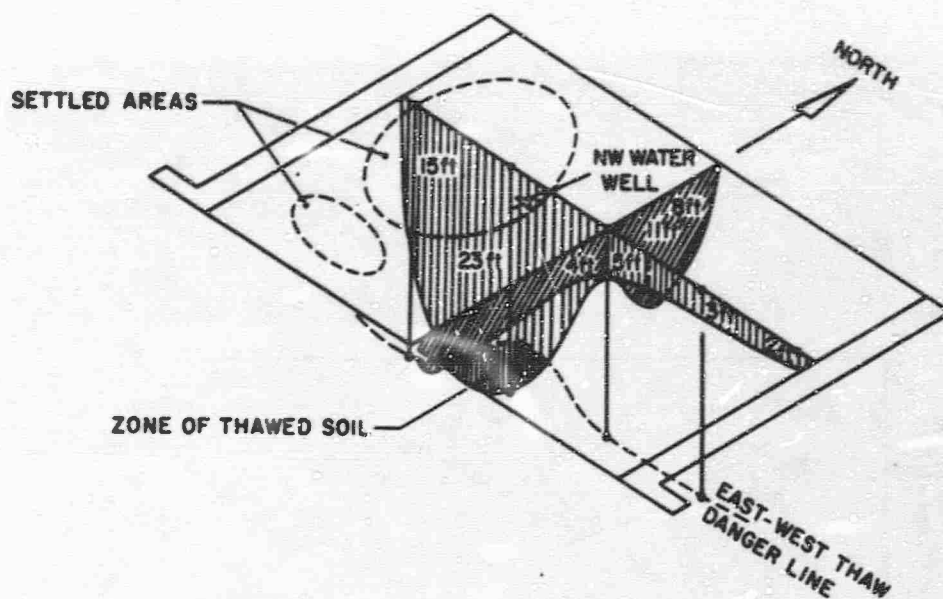
Figure 18. Measured Thaw Penetration, Hangar 10, 9 January 1969

a depth of 23 feet near the northwest water well as shown in figure 18. It is felt that concentration of ground water flow by pumping is responsible for localized deep thaw penetration near the well. The soil borings obtained in that hangar permit locating the thaw line and the zone of thawed native soil. The center of the large depression dish is about 2.3 feet below the hangar floor at the southeast corner.

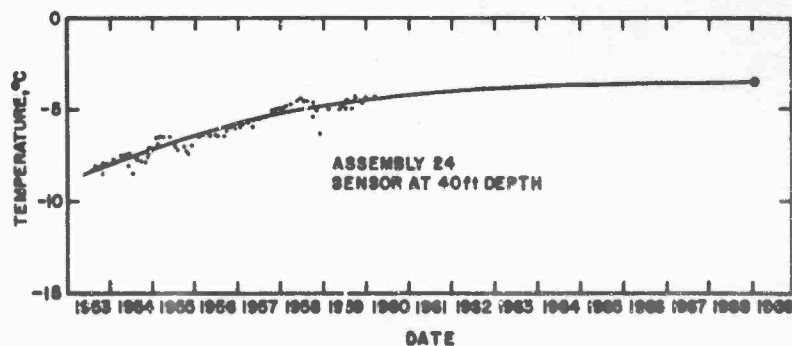
Figure 19. Progressive Warming of Soil 40 Feet below Hangar 10

Warming is also present under hangar 10. Sufficient data are available to indicate that the rate of warming at depth is decreasing as shown on figure 19. This indicates that a steady state heat flow condition is being approached and the rate of thaw penetration is slowing down. This is further documented by elevation surveys conducted by the personnel of the Base Civil Engineering Division which indicates that the rate of floor settlement in hangar 10 has decreased since 1963 (figure 20).
